Leak Masters LLC

Claim # XXXX-XXXXX-XXXXX

PROPERTY ADDRESS REDACTED

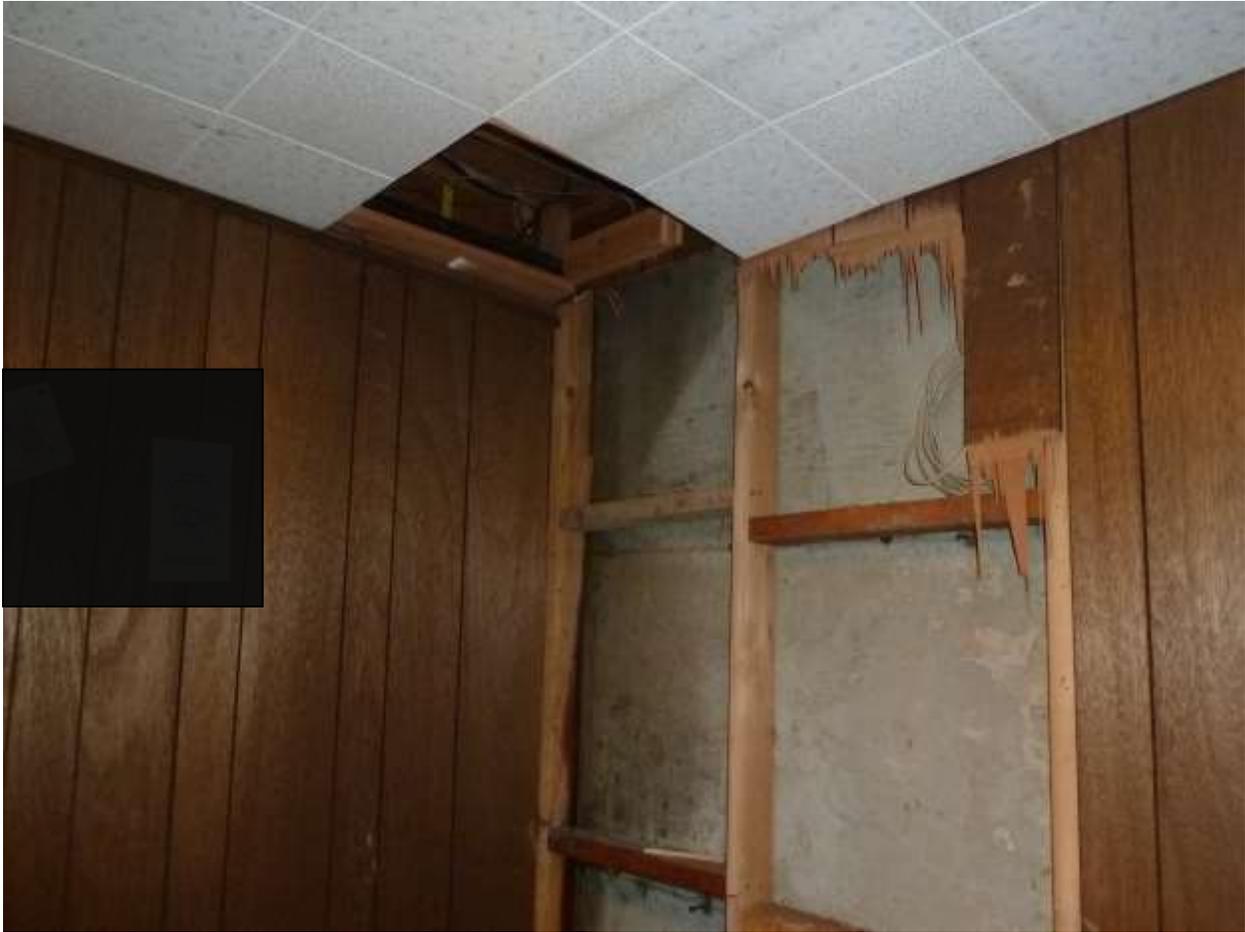
This is the corner of the room which had the cabinet. This had a cabinet that was nailed up against the wall, and ceiling. There was no access to find this leak if we did not remove this. You can see the concrete at top of picture it is somewhat darker on the left side. The leak is up in this corner.

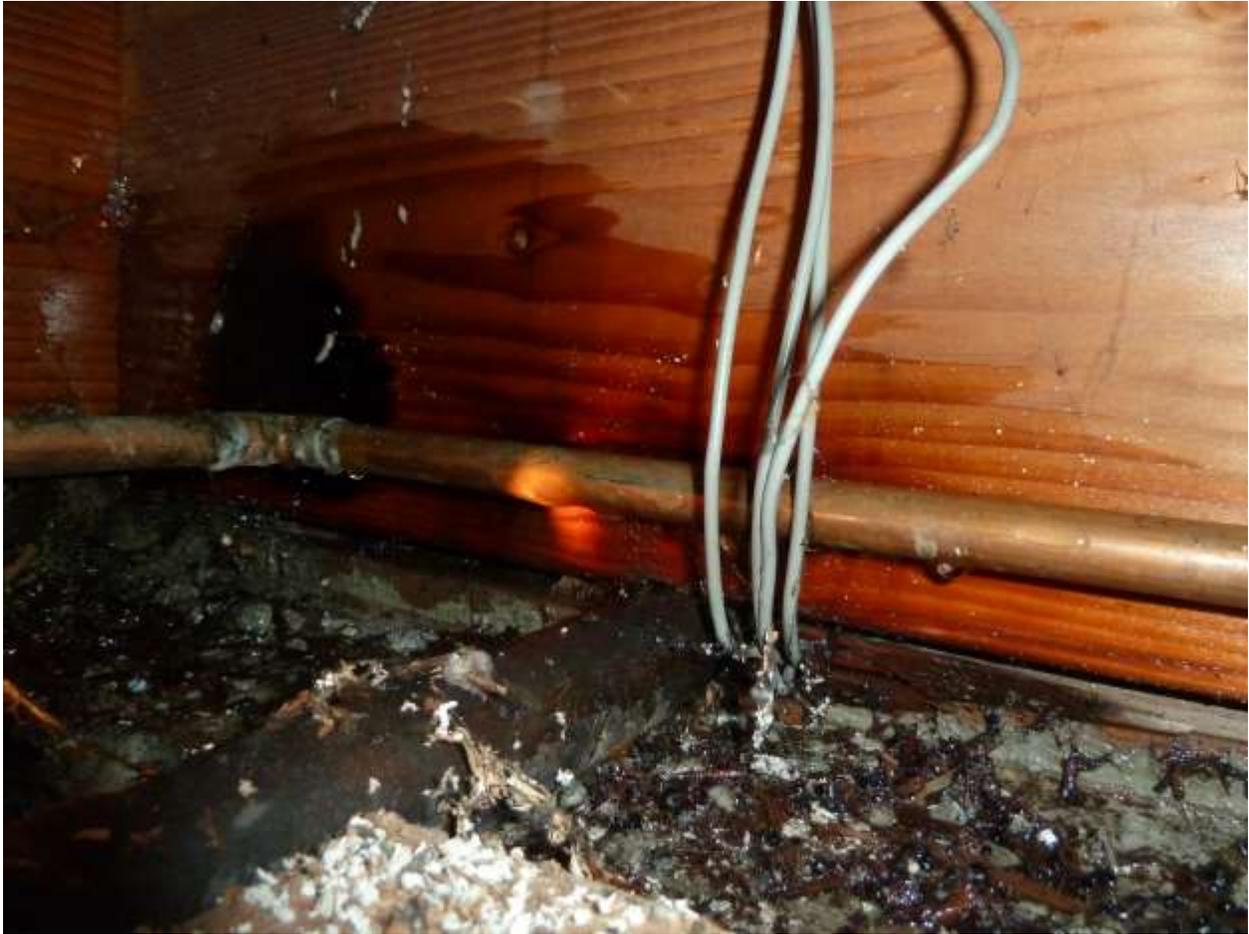
This is the pipe that is leaking you can see the small amount of water dripping from it. The leak is actually just to the left of these wires in the picture. The black mark on the wood is from soldering up the pipe right next to the wood. The main gas line is the black pipe that is just under the copper line that goes to the left.

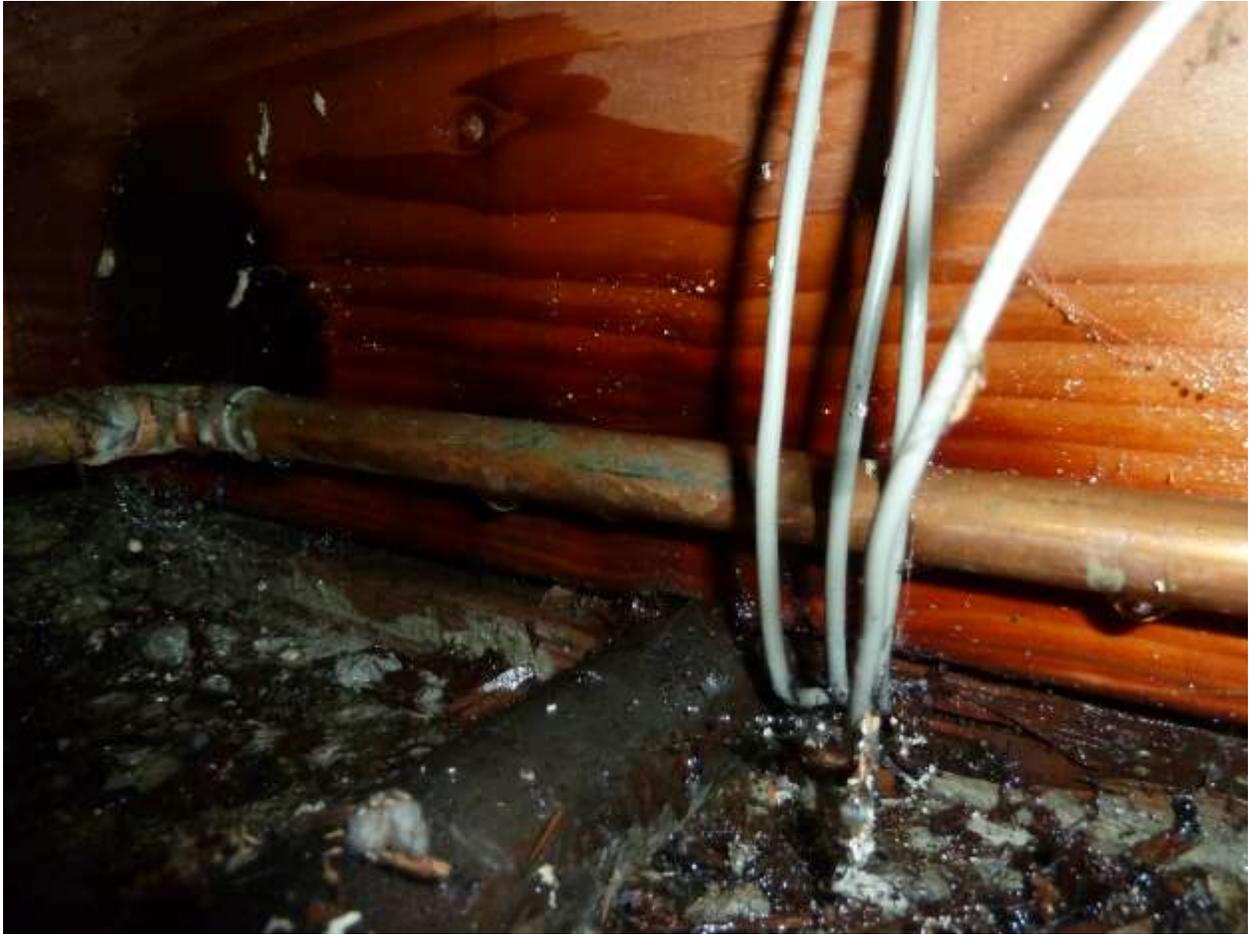
This is the same picture you can see the small mist of water against the wood just above the pipe.

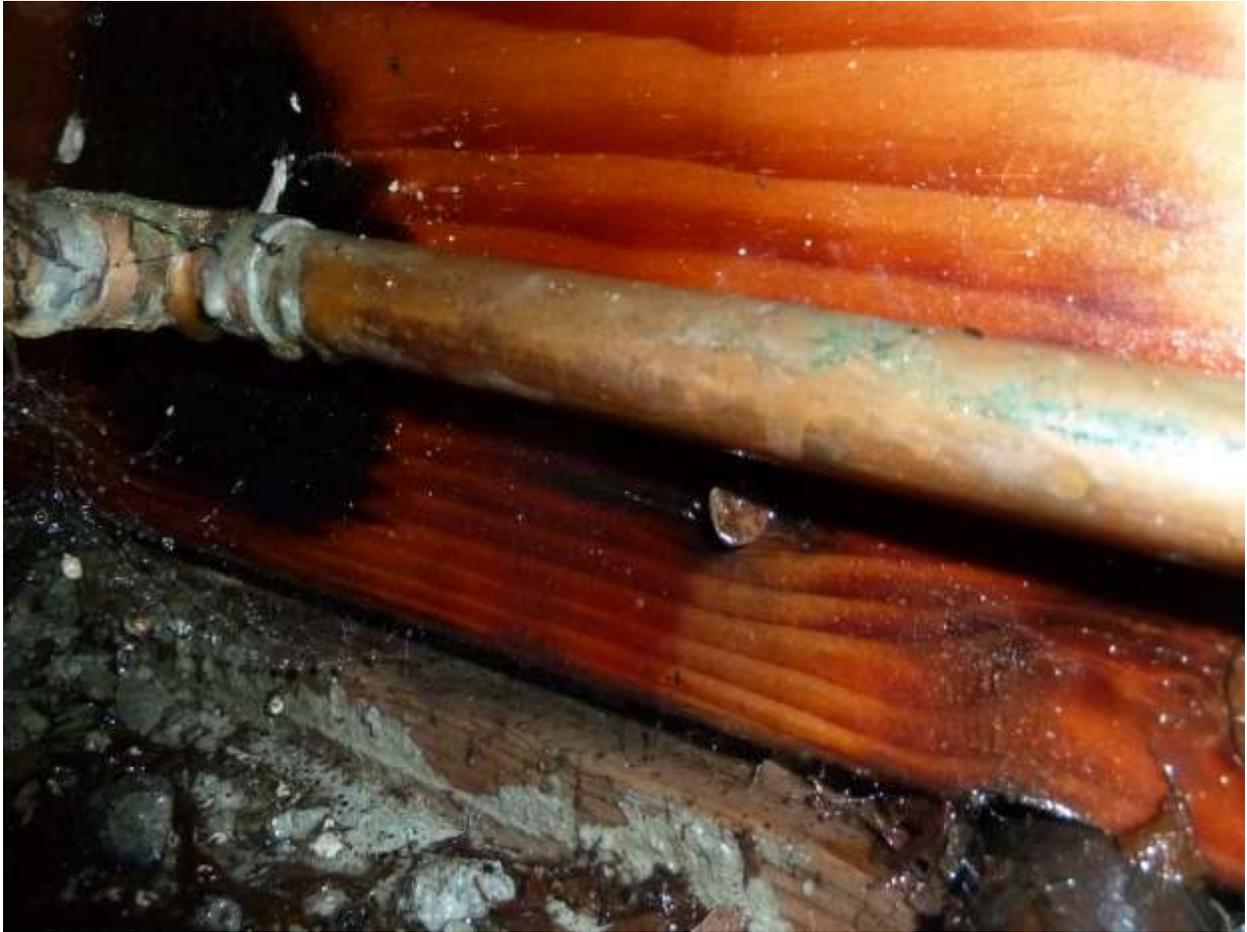
This nail head in the center appears to be where the leak is spraying from. The pipe was nailed directly up against the outside perimeter wall and it looks like it rubbed on this nail head. I could feel with my hand that the water was spraying right next to the head. Again a very small fine mist type of leak. I know we would have never found it without removing the cabinet and part of the ceiling.

They may still have a ground water issue because of how the gutters were run and the vast amount of water around the home and in the meter box. But this copper line seems to be the reason for the extra water in the basement. I think it should be fixed and dried out and then watch the wall to make sure nothing else appears.
